Major accidents having significant impact to the environment

Lessons Learned Bulletin No. 3 CHEMICAL ACCIDENT PREVENTION & PREPAREDNESS Major accidents having significant impact to the environment

**Number 3
JUNE 2013**

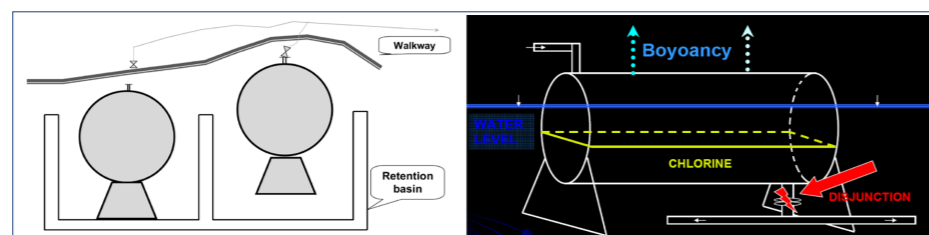
The containers were lifted by the force of the flood, which led to a burst in the piping and detachment of the socket on a tank. The tanks in the chlorine storehouses contained different amounts of chlorine. Some contained only gaseous chlorine as a residue after discharging, some were filled up to 20% of the capacity and one tank was practically full. After being flooded with water exceeding the 'hundred year water level' by 1.3m, the empty and lighter tanks were lifted by buoyancy forces and displaced from their normal positions. The buoyancy forces were so strong that their action deformed and lifted the walkways situated above the tanks (see above). The closing valves in the full tank got caught by the walkway and were completely torn off as the walkway kept moving upwards. As a consequence of the valves being torn off from the full tank, a massive leakage of chlorine occurred.

The release

- The storage tanks/containers were not fixed to the ground, therefore they could be lifted by the flood water. Storage tanks/containers encompassing dangerous substances should be fixed to the ground.

- The walkways were attached to each other, therefore once one container was lifted, it also lifted the adjacent container too. To avoid this kind of chain reaction, the walkways should be segmented.
