Lessons Learned Bulletin No. 7

CHEMICAL ACCIDENT PREVENTION & PREPAREDNESS

Major accidents related to ageing

Number 7
June 2015

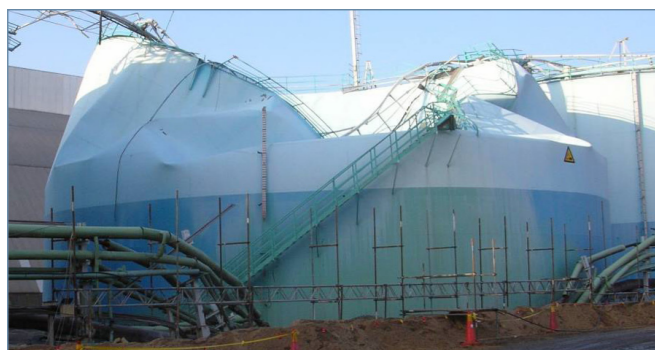
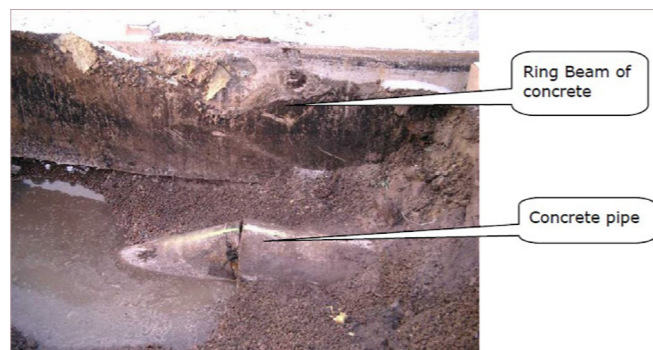
The cause of this incident was a leak in an underground coolant supply pipe of reinforced concrete installed over forty years before that resulted in a weakening of the ground under the tank farm. Apparently, water forced its way out of the pipe, eroding the ground near and around the sulphuric acid tank. This erosion damaged the ground under the tank which ultimately failed due to the lack of support of the tank floor. A study of the appearance of the involved part of the coolant supply pipe suggests that the corrosion was a result of an acidic attack on the concrete.

- The pipe had been in use over many years and the operator had no suspicion that the pipe was suffering severe degradation. The inspection of the failed pipe after the incident detected little or no internal corrosion, but heavy external corrosion to the concrete. In certain places the concrete had corroded so severely that the reinforcing steel was exposed.

- According to the German standard, DIN 4030 (equivalent to the European standard, EN 260) a strong attack on concrete occurs if the pH level in surrounding water is < 5.5 and a very strong attack can occur if the pH level is < 4.5. Fifteen years before the accident a ground pollution study was carried out in the area, during which one of the sample taking points was close to the failed coolant supply pipe. At this point the pH level was measured at 4 in the shallow groundwater. With this knowledge the company drew the conclusion that this pH level entailed risks for strong acidic attacks on the concrete.

Figures 1 and 2: The damaged tank and underground pipeline (Source: Swedish Investigation Board report).

- The uneven corrosion on the outside of the pipe can possibly be explained by the fact that it lay partly in groundwater flow. In this environment, the acid can pass through the barrier more easily, and the reaction products (gypsum) formed can be more easily dissolved. As such, the concrete barrier was not as effective as on the part of the pipe that remained in drier surroundings. Therefore, concrete piping exposed to ground water should be subject to protective measures, monitoring and inspection to take into consideration the increased risk from groundwater exposure.

- Similarly, underground piping that entail risks to foundations should be inspected and measured.
- There are a number of strategies that can be applied to piping where there is accelerated potential for degradation or where there are high consequences should significant degradation occur. Pipes may, for example, be tested for stability (remains in place) and hydraulically checked on a regular basis. Alternatively, consideration should be given to positioning the pipe above ground. The pipe could also be placed in casings, especially where a leak may cause damage to the surroundings or where pressure and ground deformation may cause damage to the pipe.

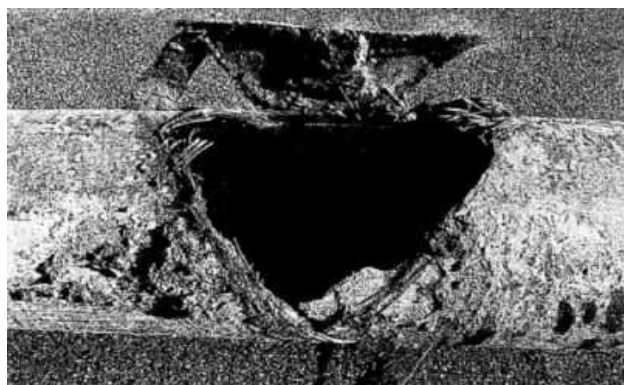
Figure 5: The damaged pipeline (Source: ARIA No. 23562)

Deterioration of the infrastructure was due to a corrosion mechanism occurring in an acid-stressed environment. A number of factors contributed to this accident. One factor is ageing. The corrosion of the pipe material caused an effective loss of strength. In addition, the process design did not adequately address the pressure surge that could occur when the pump is shutdown, in particular, insufficient number of vents made difficult to cope with this situation that is a routine part of the process. Furthermore, there was a failure in installation because of incorrect setting of the surge chamber pressure.

- Leaks were primarily noticed adjacent to pipe elbows and during directional changes. The pressure never exceeded 5 bar vs. a 10-bar design pressure, in a diluted sulphuric acid medium with a temperature below 35°C. The maximum temperature allowed for GRP tubes was 50°C. Therefore, the fact that failures occurred near or at high points and near a change in direction, confirms the role played by hydraulic transitions.

- It was demonstrated that the damage to the pipe was due to a mechanism of stress corrosion in an acid environment. Stress corrosion is a fissuring mechanism that requires a combination of three factors, such as stress or permanent distortion, the material sensitive to the phenomenon and a corrosive environment.

- There was a design problem in this case, due to the insufficient number of vents available to cope with the pressure surge. This is a phenomenon that generally occurs in long pipelines; key factors are fluid velocity, pipeline and rate of valve closure, or in this case, pump shutdown. It can cause a very high pressure surge which travels along the pipe at the speed of sound in the fluid. The vents are provided to alleviate this surge as was the surge chamber - this to minimize any low pressure surge as the pump is shut down.

- Although the pipes and their assembly complied with the provisions in the regulations as required by the project service order, the installation of the pipe and pressure control systems were not in accordance with good custom and practice. In particular, they were not compliant with the original installation specification, sizing of the buffer chamber and calculation of the number of vents required.

- Even without the mistakes in design and installation, corrosion of critical components of the equipment would ultimately have led to failure, and therefore, should be subject to a systematic inspection program similar to all safety critical elements.
