TECHNICAL COMMITTEE FOR PLANT SAFETY

Evaluation of the Experience Reports

on Safety Checks by Experts

TAA-GS-36.1-K

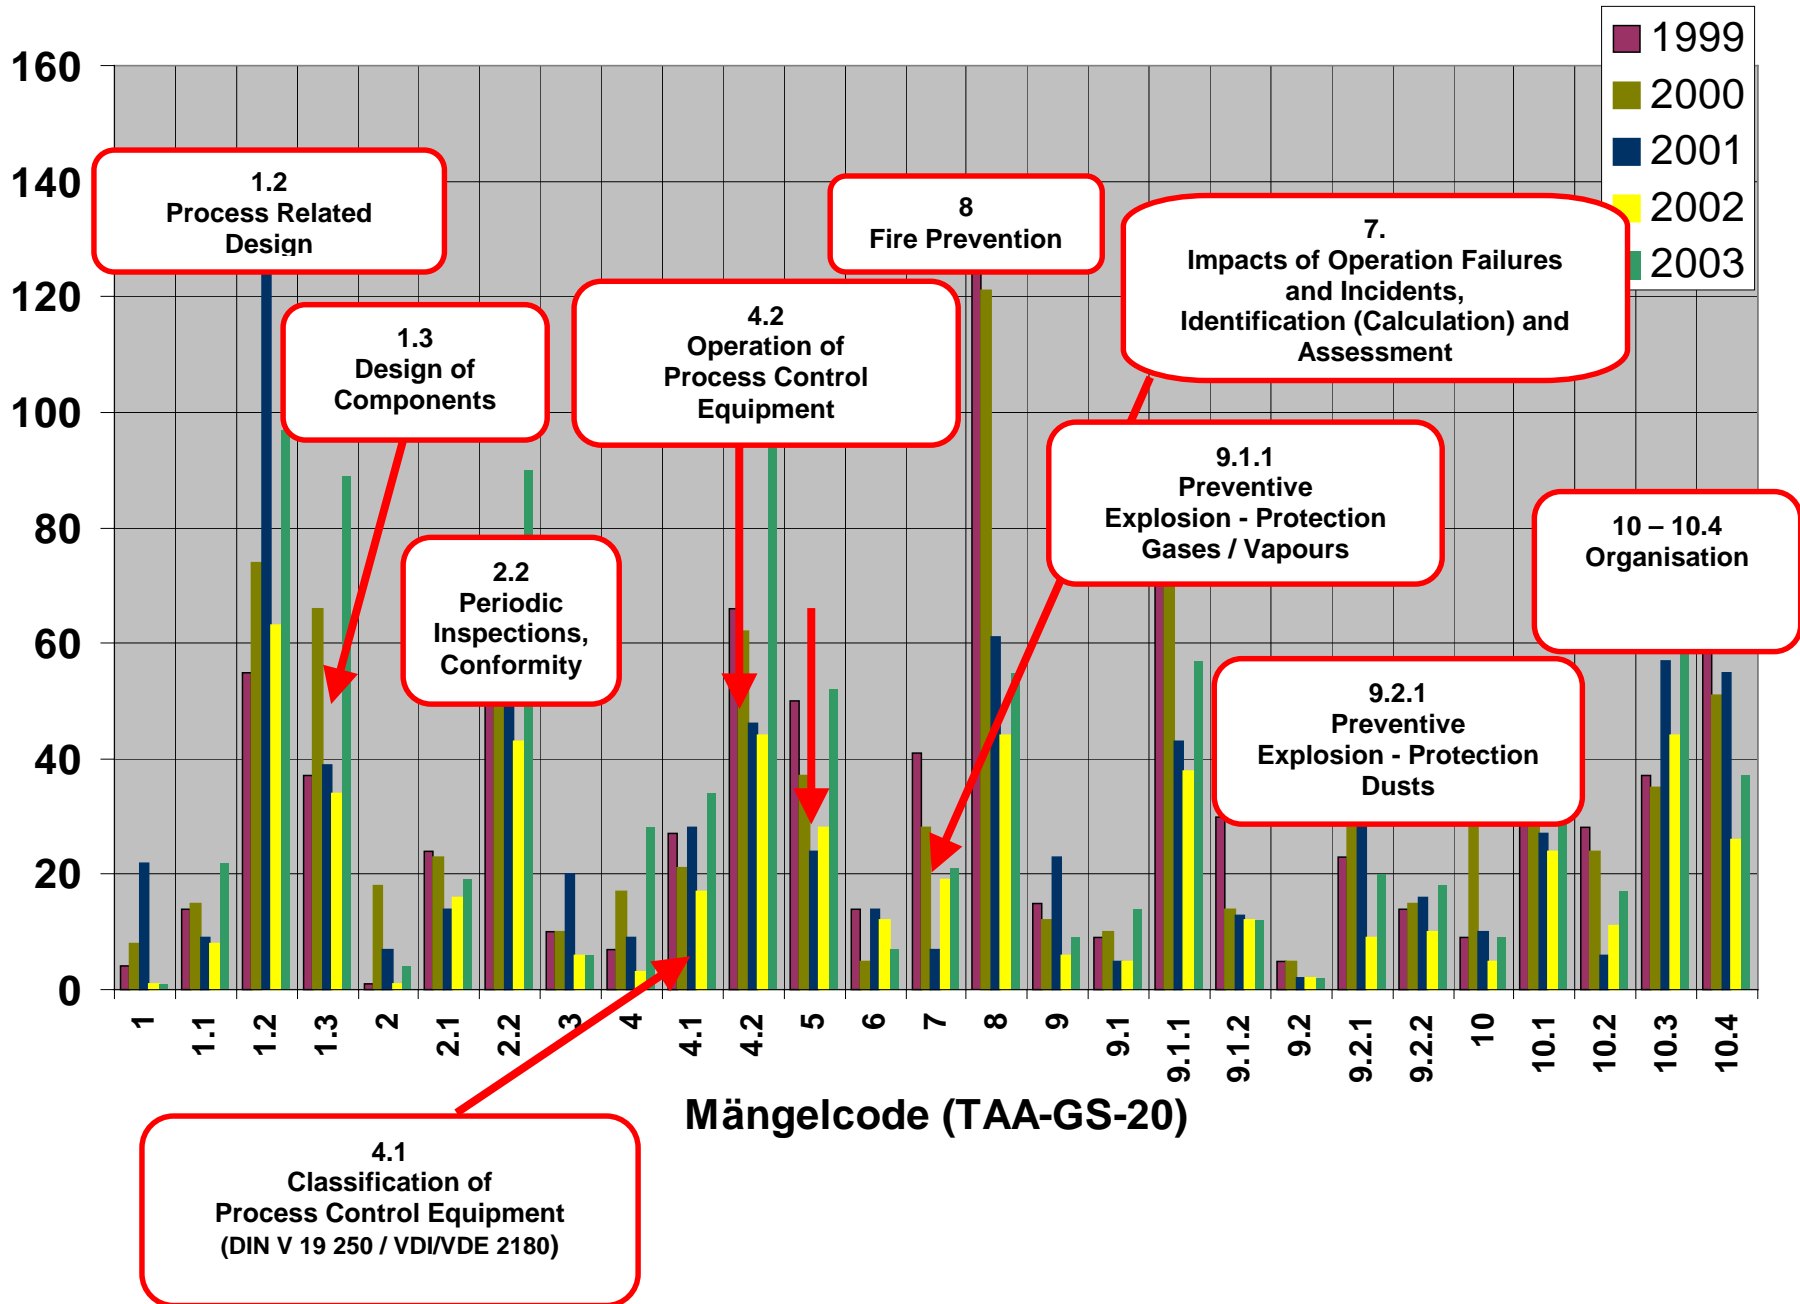
Failure Codes – Frequency of Occurrence 1999 - 2003

By way of summary it can be noted that the bulk of shortcomings often occur in the same areas they did for the 1999 to 2002 period, displaying marked deficiencies in the following areas: (constructional) fire prevention, explosion prevention, process control engineering, process related design and organisation. Inadequate execution of safety-checks and deficiencies of systematic examinations are also bulks of shortcomings in 2003 (see graph below).

Code	Topic
1.	design of plants and plant parts taking into account potential strain during a disruption of normal operation
1.1	design and dimensioning of construction components (earthquake resistant construction, wind loads, other loads)

1.2	process related design (process management, plant protection concepts)
1.3	design of components (design and dimensioning, materials, strain imposed by pressure, temperature, media)

2.	quality assurance and servicing of plants, checks
2.1	maintenance and repair works
2.2	periodic inspections (start-up check and regular checks), conformity

5.	considerations concerning systems analysis (hazard analysis, safety analysis)
6.	chemical, physical, human-eco toxicological properties of substances and preparations (determination and/or assessment of toxicological, chemical, physical and reaction engineering properties of substances and preparations)

7.	impact of operation failures and incidents, identification (calculation) and assessment (hazard scenarios)
8.	fire protection, retention of fire-fighting water (constructional fire protection, early detection of fire, fire-fighting measures, fire loads, retention of fire-fighting water)

9.2	dusts
9.2.1	preventive explosion protection
9.2.2	constructional explosion protection
10.	organisation
10.1	alarm and hazard prevention plans
10.2	escape and rescue routes
